Collision between the *Riley Elizabeth* Tow and
US Army Corps of Engineers Barge Plant
Mississippi River near Waterproof, Louisiana
July 18, 2014

Marine Accident Report

NTSB/MAR-15/03
PB2016-101374

Abstract: This report discusses the July 18, 2014, accident in which a downbound tow on the Mississippi River collided with a revetment project barge plant. No one was injured in the accident; however, the damage totaled about \$300,000.

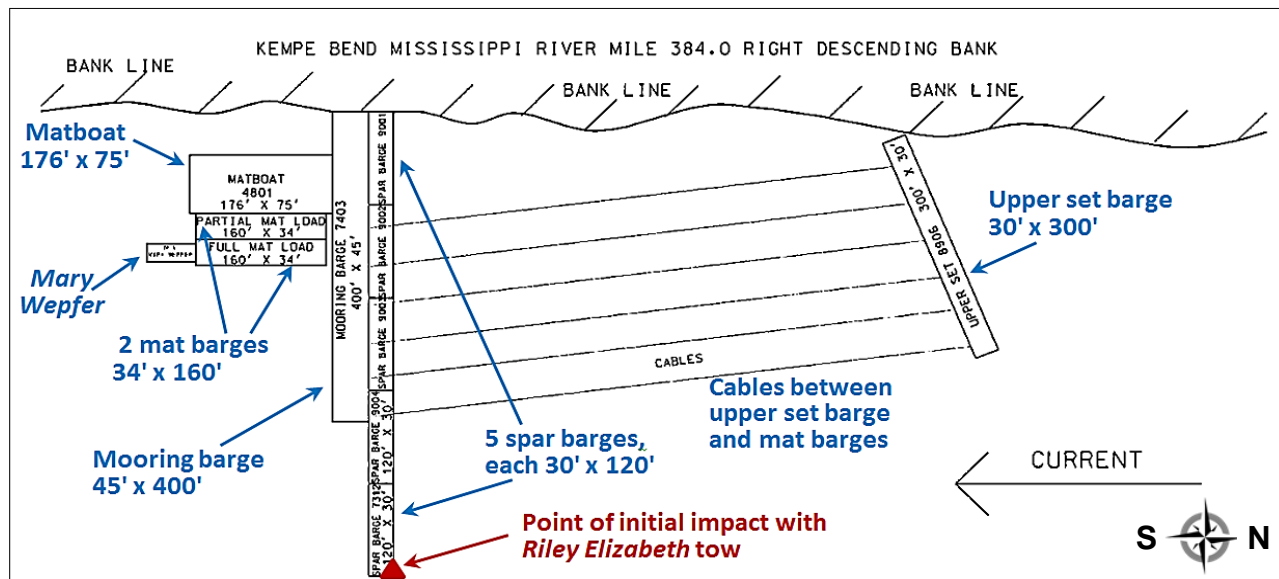
Figure 7. Excerpt from a Corps of Engineers drawing, created after the accident, depicting the layout of the barge plant as if seen from above. (Image provided by the Corps of Engineers) Also see figures 8 and 9.

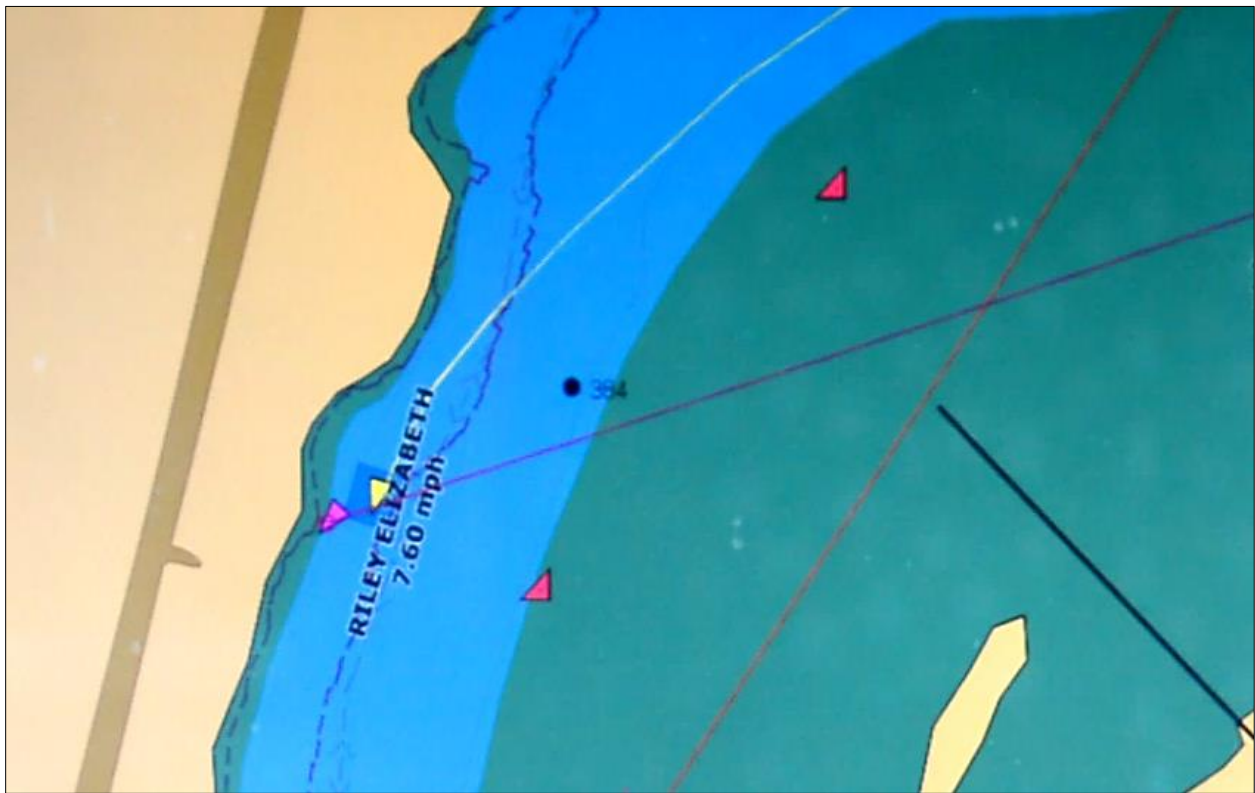
Figure 10. ECS screen shot from the time leading up to the collision. The *Riley Elizabeth* appears as a yellow triangle with a yellow line indicating its trackline (note that the tow extends 1,000 feet in front of the towing vessel itself; only the vessel appears in this image). Towing vessel *Mary Wepfer*, which was part of the Corps of Engineers barge plant, appears as the light pink triangle to the left of the *Riley Elizabeth*, closest to the riverbank. The two dark pink triangles in this image are buoys. (ECS recording from on board the *William James*) The blue and teal colors indicate water.

The Corps of Engineers barges were not electronically marked in any automatic identification system (AIS), and were therefore not visible on the *Riley Elizabeth* ECS.⁴ The mate told investigators that, based on his assessment of the radar before committing to slow-steering around Kempe Bend, he did not perceive any barges extending into the river. The tow was about 2.5 miles upriver from the barge plant at that point. Moreover, the *Riley Elizabeth* mate expected the Corps of Engineers barge plant to be “folded for the night”; that is, moored alongside the riverbank and not extending perpendicularly into the river.

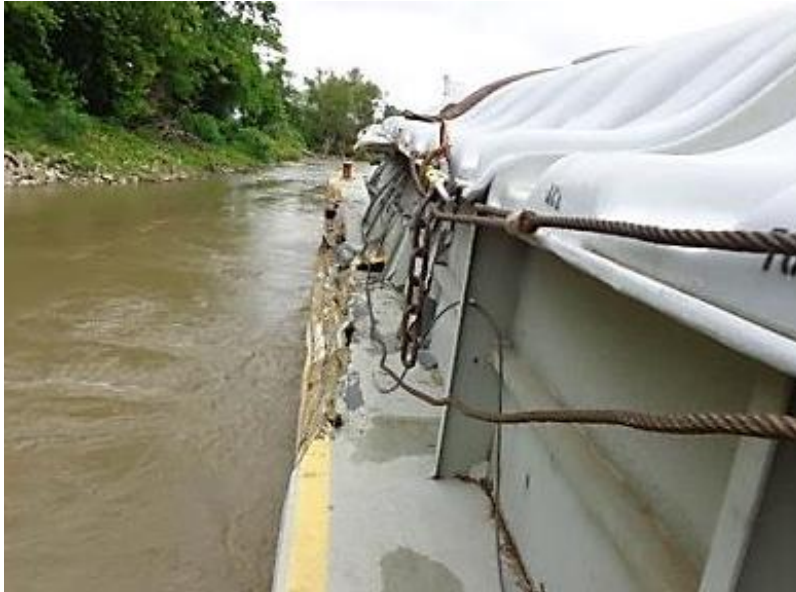
Damage to the *Riley Elizabeth* tow included shell plate punctures and insets to two barges on the starboard side of the tow—the second barge from the head of the tow and the aftmost barge (figures 11 and 12). The *Riley Elizabeth* hull was punctured and inset near the stern on the starboard side. Neither the vessel nor the barges took on water. Damage to the *Riley Elizabeth* and the two barges was estimated at \$100,000.

Figure 11. Damage to the starboard side of the aftmost barge in the *Riley Elizabeth* tow. (Photo by the Coast Guard)

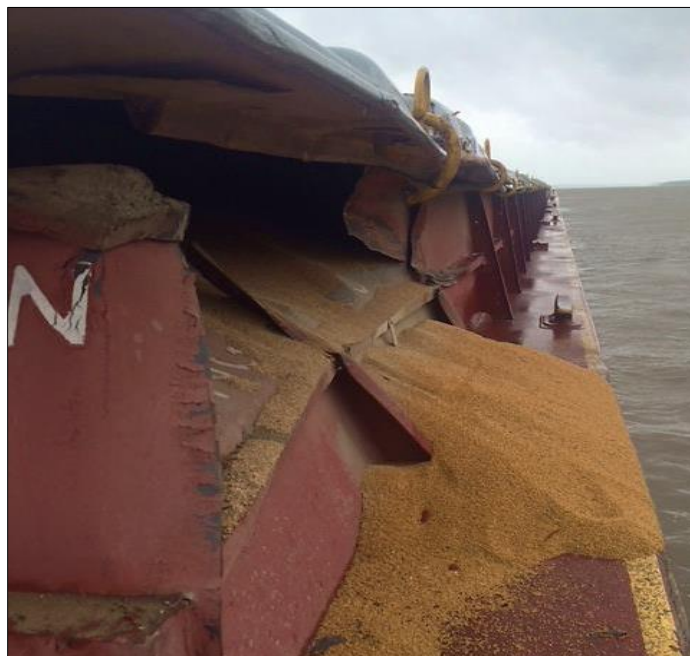
Figure 12. Damage to the starboard side of the second barge from the head of the *Riley Elizabeth* tow. (Photo by the US Coast Guard)

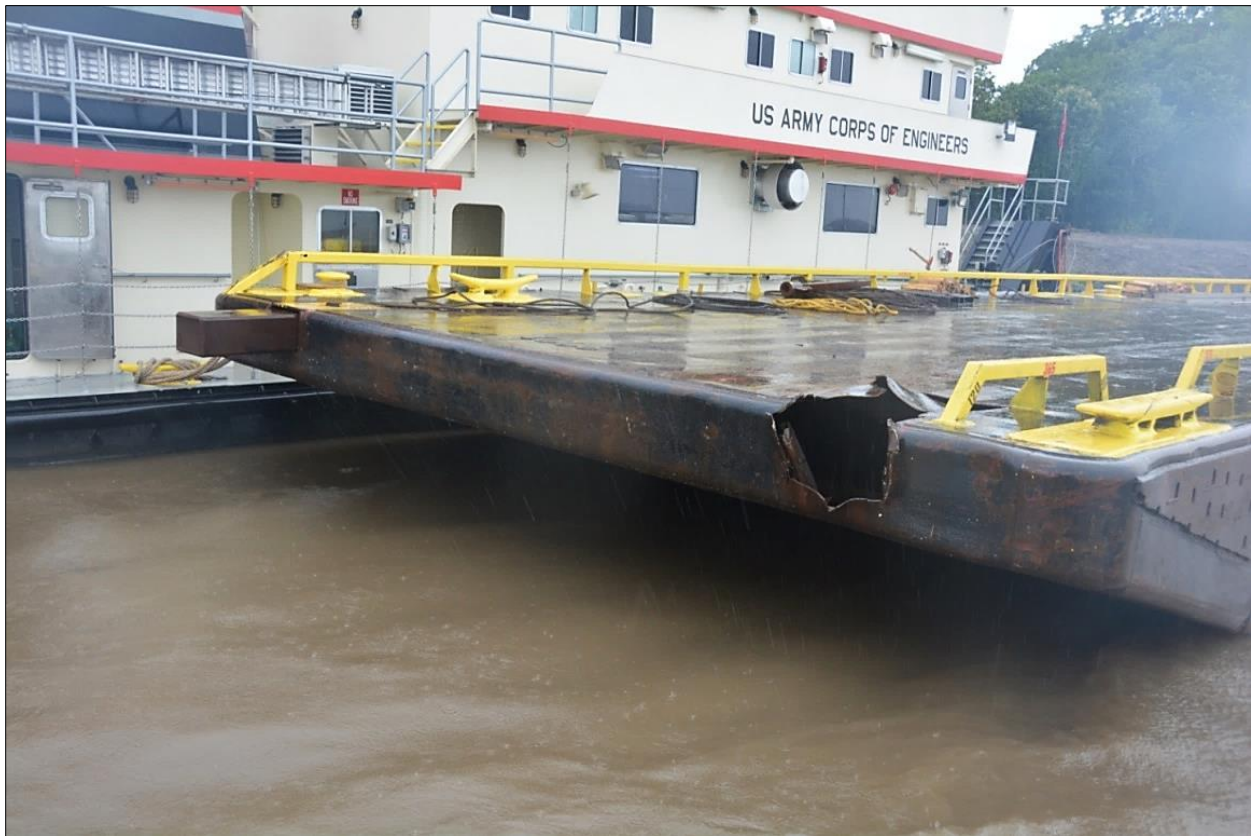
The coupling between the two outermost spar barges broke, causing these barges (nos. 9004 and 7312) to drift downriver and sustain damage (figure 13).

Figure 13. Damage to the inshore end of spar barge 9004. The Corps of Engineers towing vessel *William James* is in the background. (Photo by the Corps of Engineers)
